CRASH INJURY REPORT

U. S. ARMY U-1A
De HAVILLAND OTTER ACCIDENT
Fort Carson, Colorado
16 June 1959

Aviation Crash Injury Research
of the **F**light **S**afety **F**oundation

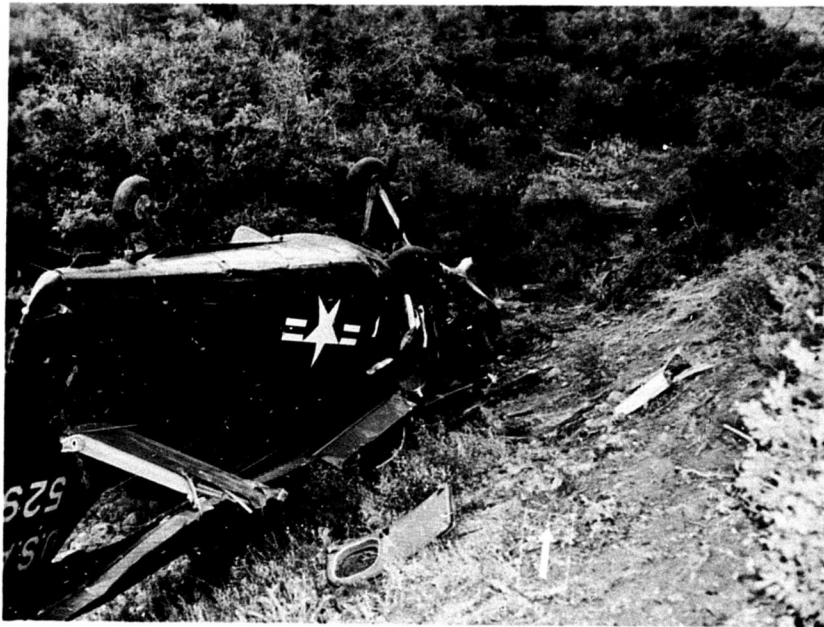
Fig. 5. View showing gouging (arrow) caused by the aircraft's decelerating along the ground following the principal impact. Note the relative intactness of the rear cabin and fuselage structure.

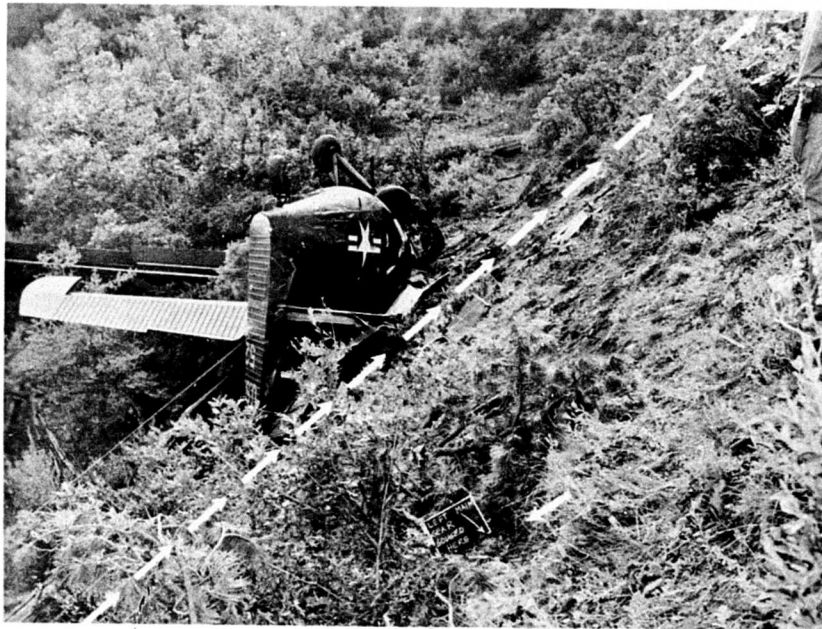
Fig. 6. The side slope of the terrain at the point of principal impact with the ground was approximately 40 degrees. Analysis indicates that the left wing of the aircraft was down about 60 degrees when the wing tip first struck the ground; this resulted in a 20-degree wing-down angle with relation to the terrain at the instant of impact. Note the gouge (arrow) caused by the left landing gear.

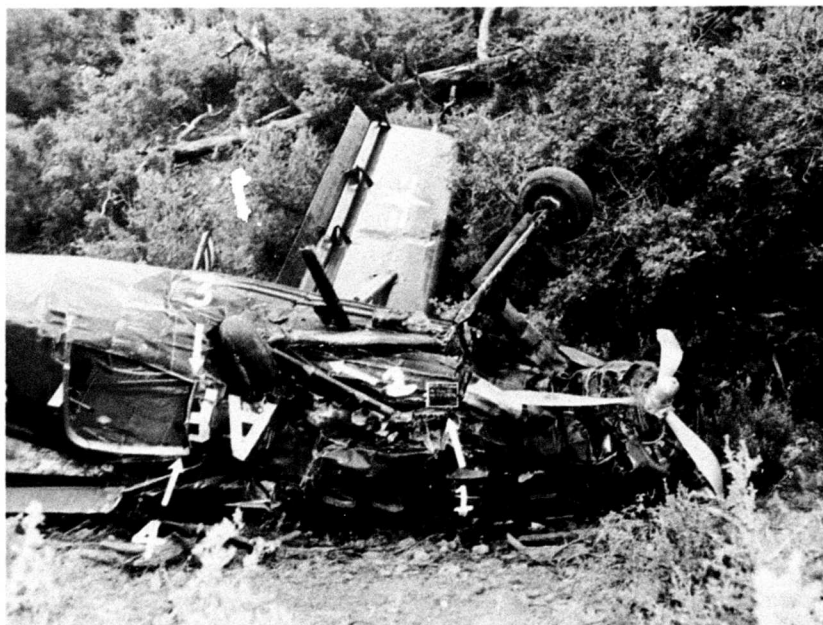
Fig. 9. The lower left fuselage section, slightly aft and below the cockpit (arrow 1), struck the ground immediately after the left landing gear collapsed. As the left gear was swept rearward and upward, fuel cells located in the belly of the aircraft were ruptured (arrow 2), and the lower main cabin door frame was distorted (arrow 3).

Simultaneously, the left wing, pivoting at its root, was forced rearward and upward as the aircraft continued to roll over on its left side. This resulted in an inward displacement of the left cabin wall and ceiling and in severe distortion of the upper main cabin door frame (arrow 4).

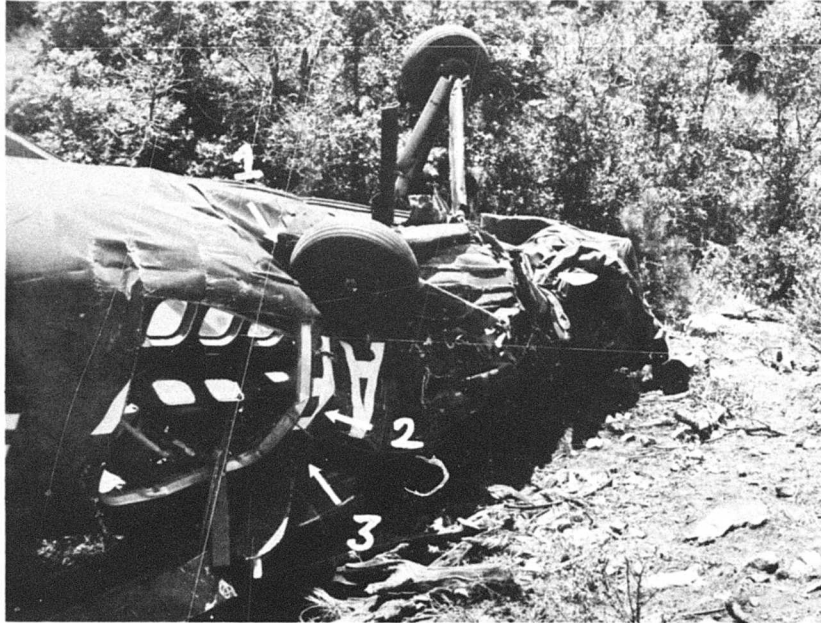
Fig. 10. View of damage to fuel cell area (arrow 1), main cabin door frame (arrow 2), and upper left cabin structure (arrow 3). Gasoline flowing downward into the cabin from the ruptured fuel cells drenched the occupants.

Although two occupants were seated adjacent to the structure that was severely damaged by the inward collapse of the wing root (arrow 3), both escaped serious injury. Upheaval of the cabin floor structure, caused by the left landing gear's collapsing upward into the fuselage area (arrow 1), occurred directly beneath the seat of one of these two occupants and resulted in partial failure of the seat anchorages.

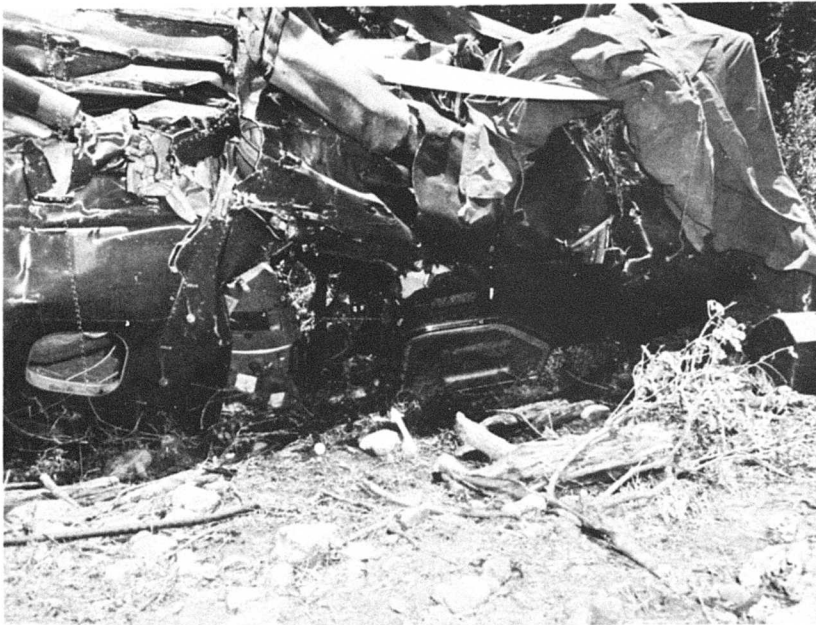
Fig. 11. The cockpit doorway (arrow), although "popped" open during the crash, was not available as an emergency exit because the aircraft was resting partially on its left side. The pilot and copilot escaped through the broken front windshield.

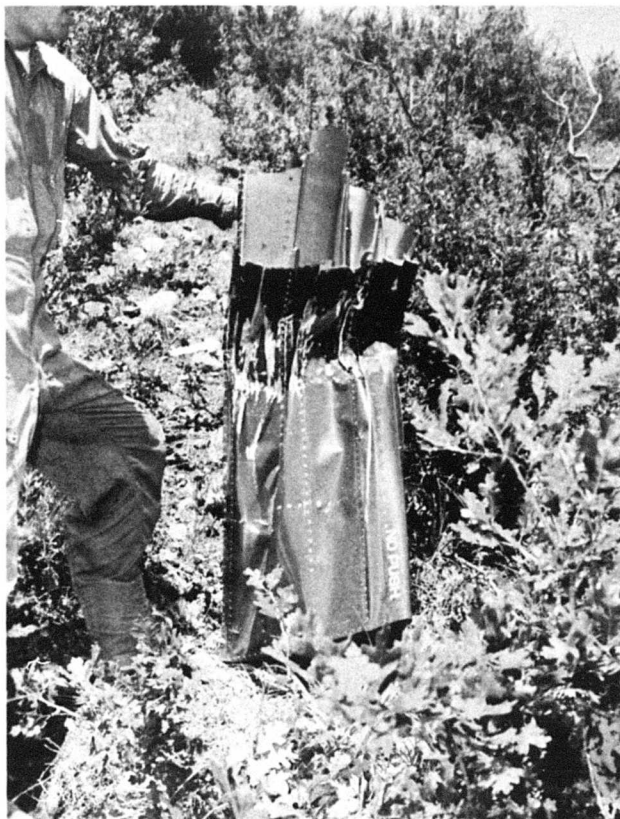
As the aircraft descended into the canyon, the left horizontal stabilizer struck the trunk of a dead tree, shearing off part of the stabilizer and elevator. (See Kinematics Diagram, p. 9, and Fig. 12, p. 21.) At the time of this impact the aircraft was flying at minimum flying speed in a nose-high attitude with the left wing slightly down. The impact caused the aircraft to yaw approximately 10 degrees to the left and to begin rolling to the left while continuing to move forward and downward.

Fig. 12. Impact damage (arrow) to the leading edge and underside of the left horizontal stabilizer was caused by initial impact with a dead tree. This outer portion of the stabilizer along with the entire left elevator subsequently tore free prior to principal impact of the aircraft with the ground.

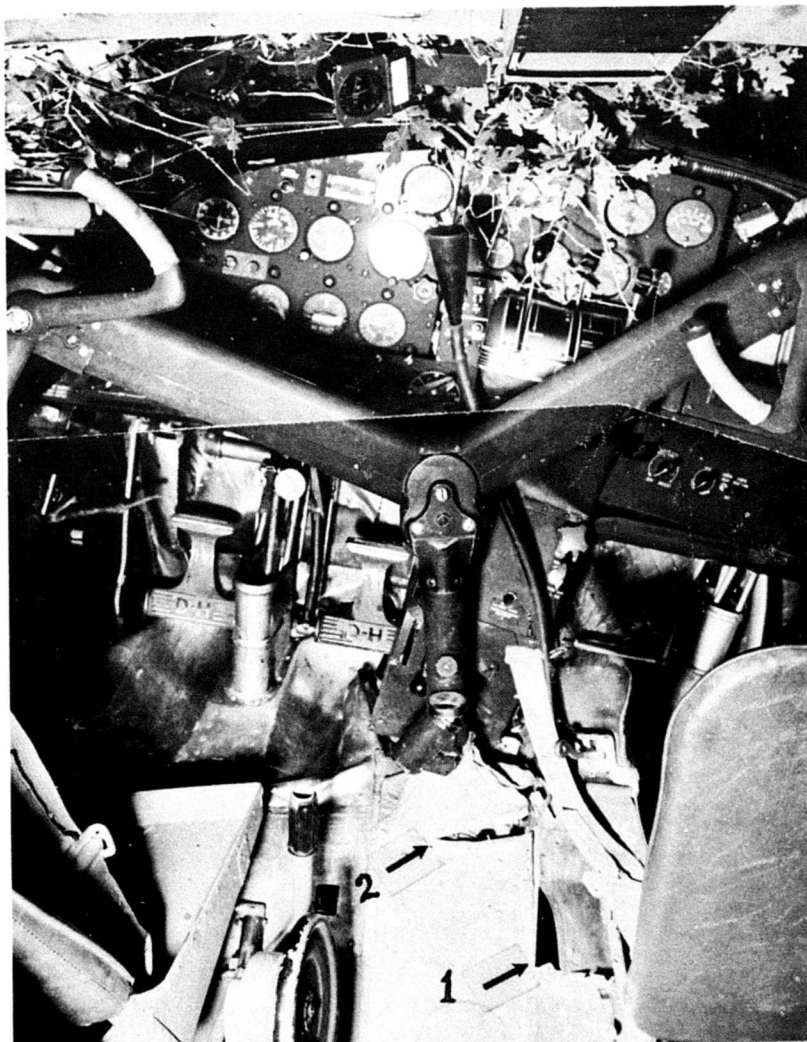
Fig. 17. Interior view (composite photo) of "intact" cockpit area. The upheaval and collapse of the floor structure (arrow 1) and the tearing free of the control column (arrow 2) probably occurred at the principal impact.

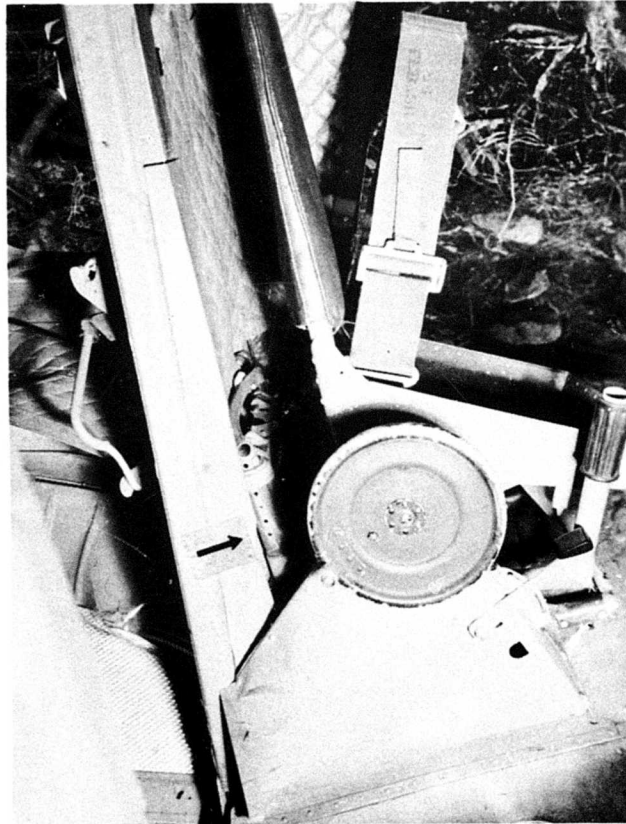
Pilot - The pilot, occupying the left front seat (Figs. 18, 30-35) received minor injuries which were sustained as he evacuated the aircraft through the broken windshield. At principal impact he was thrown forward, downward and to the left as the aircraft struck the ground. His shoulder harness, which was attached to the bulkhead separating the cockpit and cabin, functioned properly and prevented his body and head from being thrown against the control wheel and/or instrument panel.

Fig. 18. The pilot's seat was broken forward, downward, and to the left, tearing almost completely free (arrow) from its attachments to the rear tubular supporting members. The pilot, restrained by a shoulder harness and a safety belt, both of which functioned properly, sustained only minor injuries.

Analysis of the seat failure indicates that the restraint provided by the shoulder harness (anchored to the bulkhead separating the cockpit and cabin areas) prevented the seat from tearing completely free at impact.

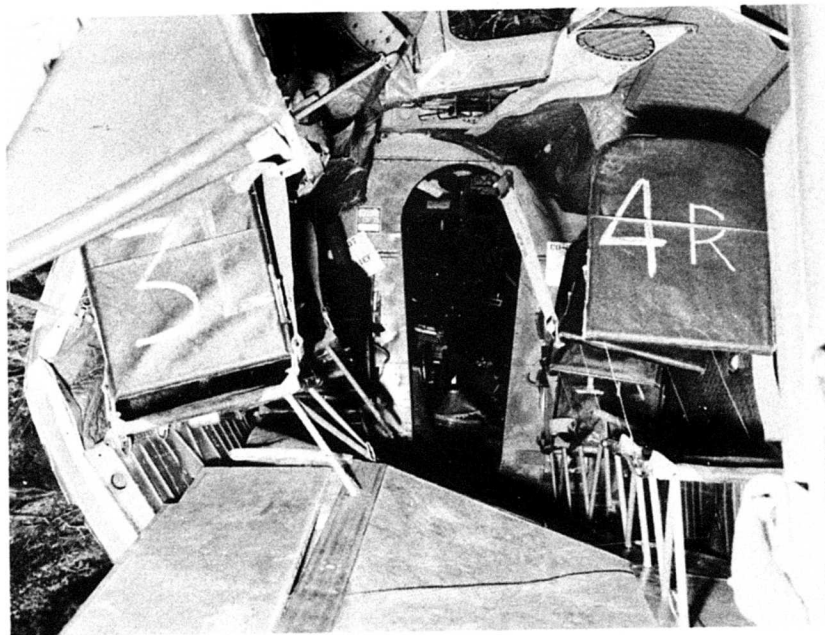
Fig. 19. View showing forward cabin area. Upheaval of the cabin floor structure was caused by the left landing gear's collapsing upward and rearward into the bottom fuselage area during the principal impact. The overhead emergency exit (arrow) popped out during the crash and was found underneath the wreckage.

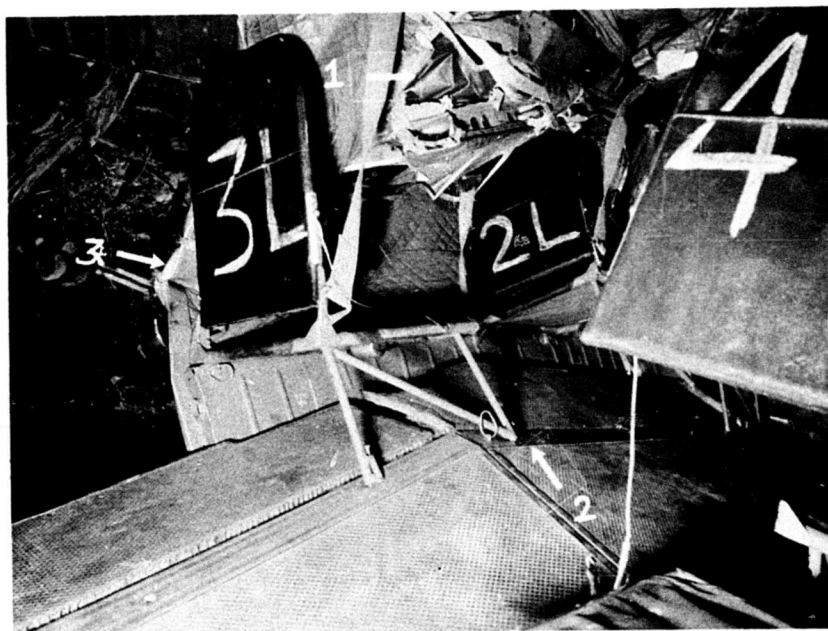
Fig. 20. Rearward hinging of the left wing root pushed the cabin wall and ceiling structure into the area (arrow 1) between seats 2L and 3L. The forward aisle attachment of seat 3L tore free from the floor (arrow 2) because of the upward displacement of the floor structure. Note the distortion of the main cabin door frame (arrow 3).

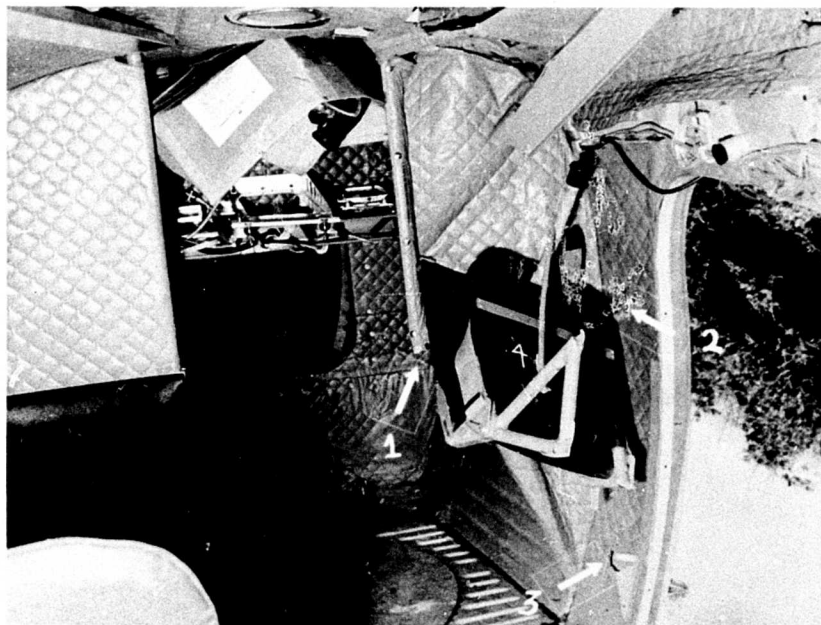
Seat 4L - The occupant of this seat (Figs. 42, 43, 47) sustained moderate injuries to his head and right knee. His injuries consisted of a 2-inch laceration on the top of his head, a 3-inch laceration on his right forehead and a torn ligament in the right knee. These injuries were caused by partial failure of his seat which allowed him to move forward, downward, and to the left, as the seat pivoted around the intact wall fitting (Fig. 24) allowing him to strike the cabin wall and rear door frame.

Fig. 24. View of after cabin showing failure of seat 4L and damage to luggage compartment. Seat 4L, normally attached to the luggage compartment post (arrow 1), to the upper and lower cabin wall (arrow 2 and 3), and to the cabin floor, tore partially free; the seat remained attached only by the upper wall fitting (arrow 2). The upper wall attachment, although intact, was badly distorted.

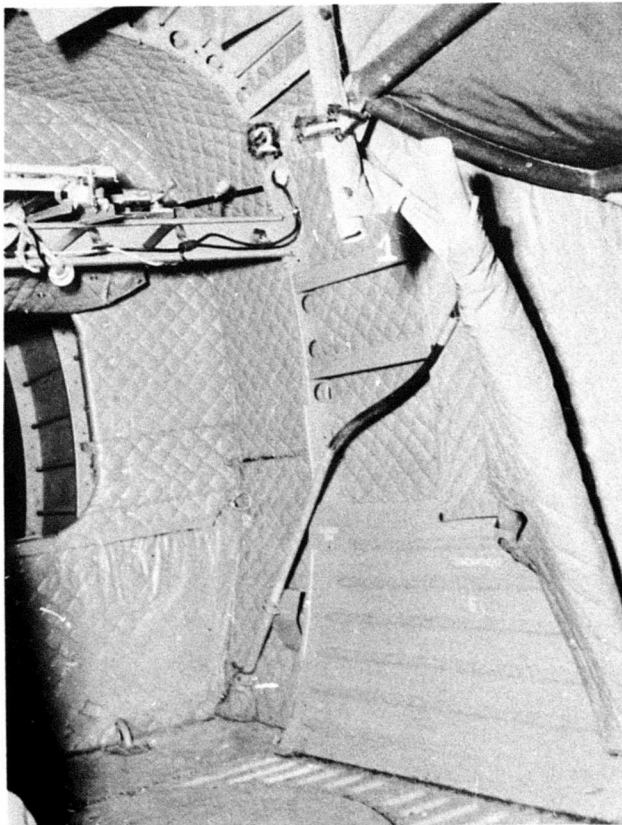
Fig. 25.
View showing failure of luggage compartment post (arrow 1) at the attachment point of seat 4L. The attachment bracket is indicated by arrow 2.

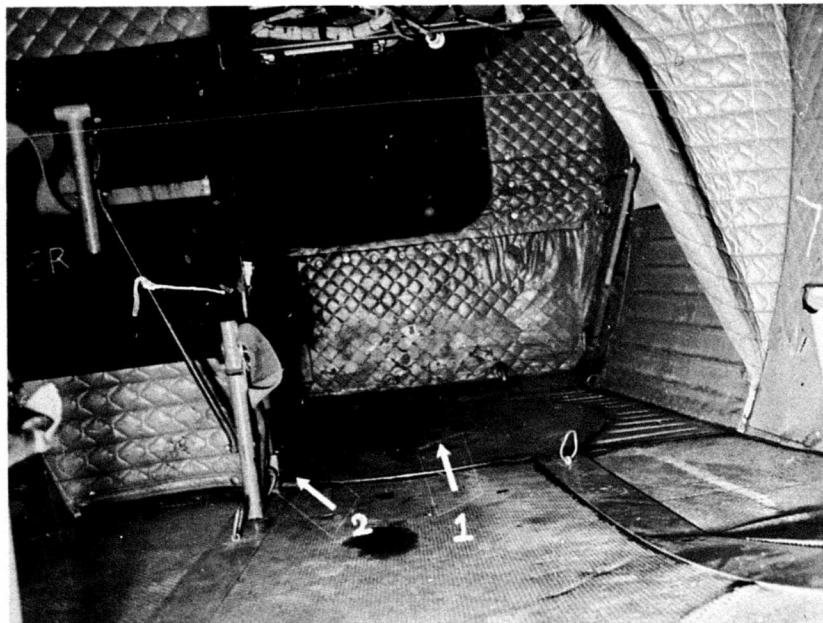
Fig. 26. View of the right-rear cabin area. A toolbox that was carried unsecured on the luggage compartment floor (arrow 1) was found rammed against the left vertical support of seat 5R (arrow 2), and impaled on two exposed bolt ends. It remained attached to them as the aircraft rolled to a partially inverted attitude during the crash sequence.

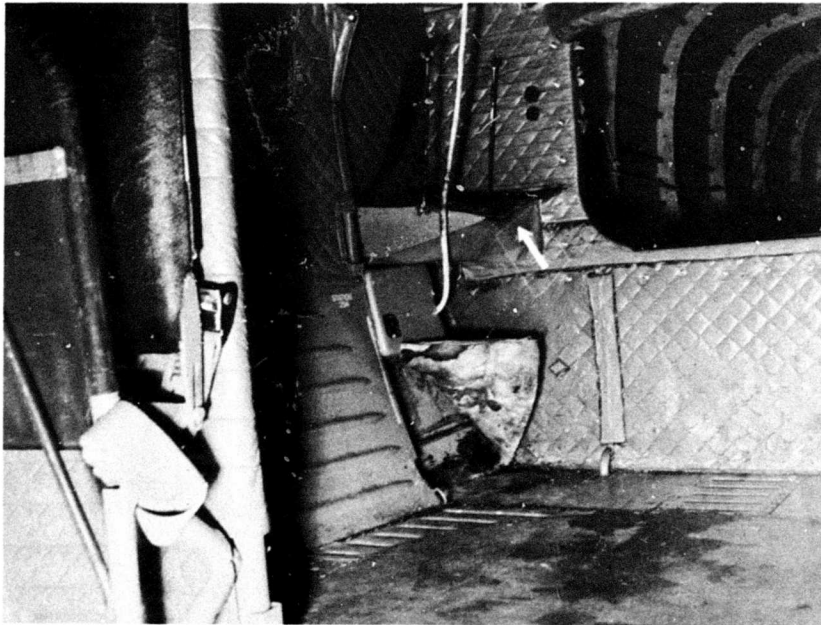
Fig. 27. View of luggage compartment showing downward distortion of the left forward portion of the battery rack (arrow).

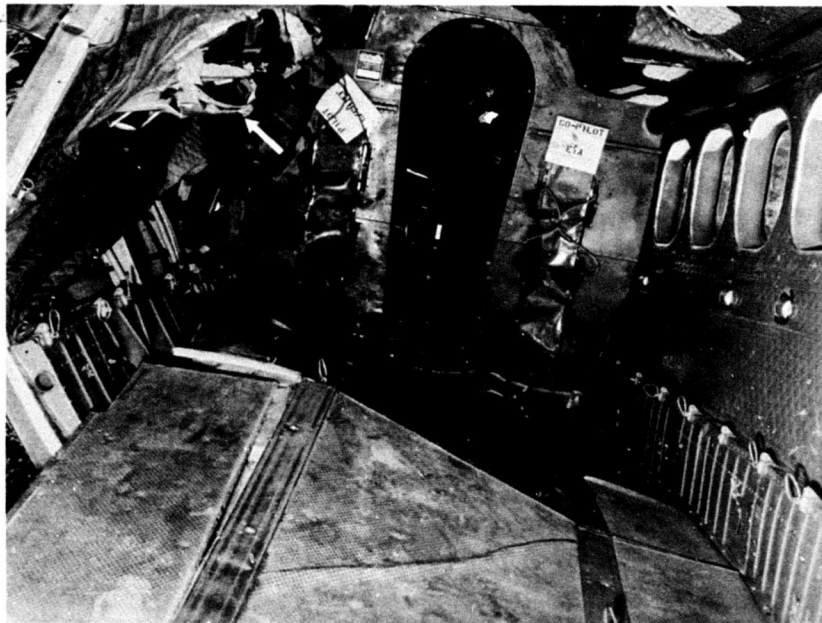
Fig. 28. Looking forward in the cabin after removal of the passenger seats. Note the upward displacement of the cabin floor and the inward displacement of the left cabin wall and ceiling structure in the vicinity of the wing root (arrow).

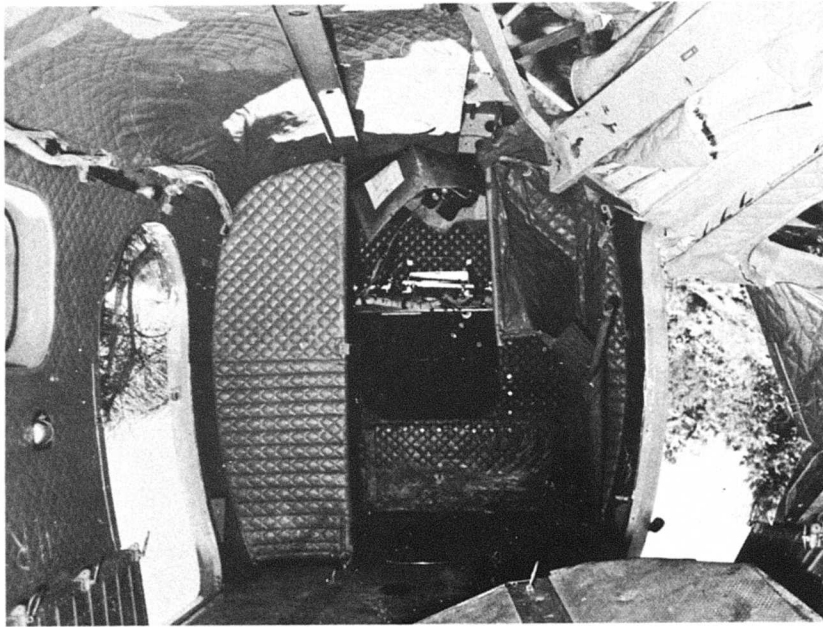
Fig. 29. Looking aft in the cabin following removal of the passenger seats. The upheaval of the cabin floor and the damage to the left cabin wall in the vicinity of the wing root are readily apparent.

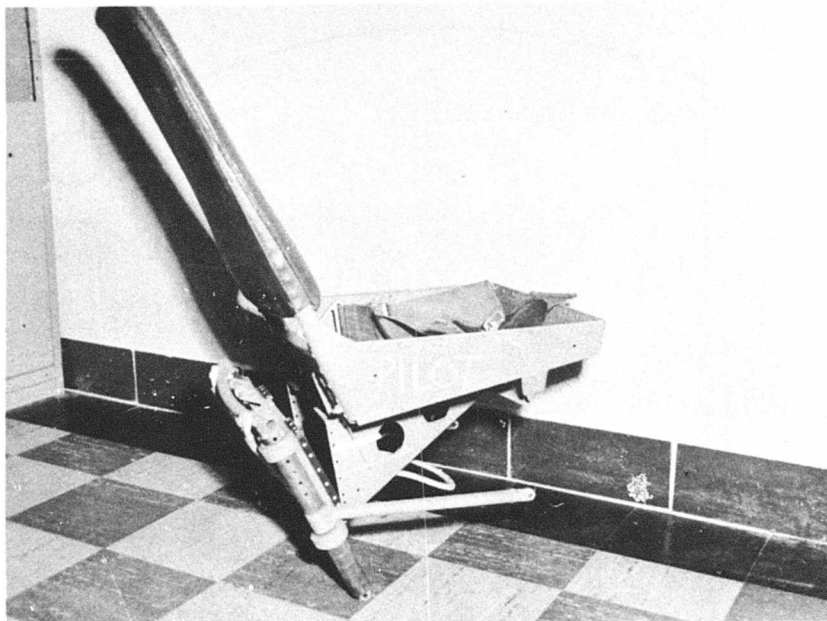
Fig. 30. Failure of the pilot's seat pan, due to shearing of the rivets which attach it to the primary support structure (arrow).

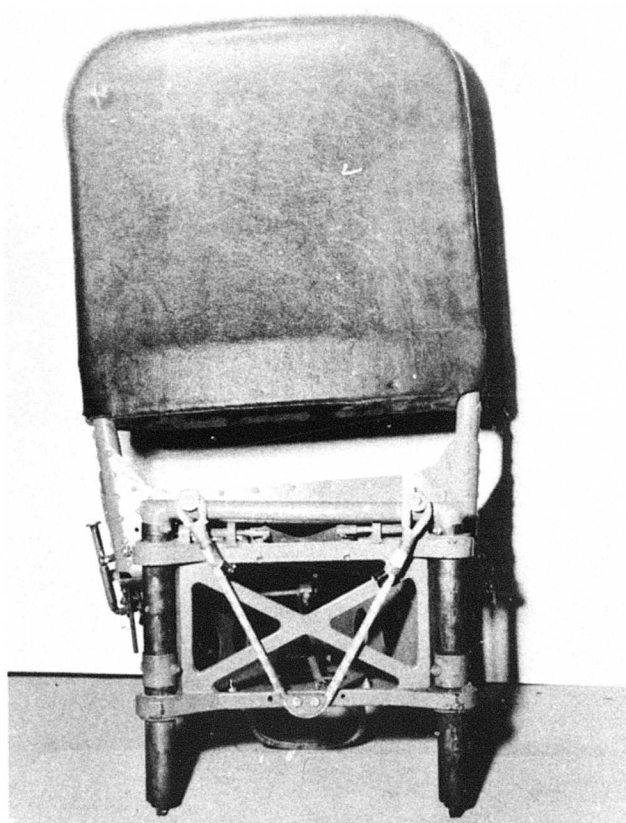
Fig. 31.
Rear view of pilot's seat. Note the distortion of the seat pan and the seat back (downward and to the left).

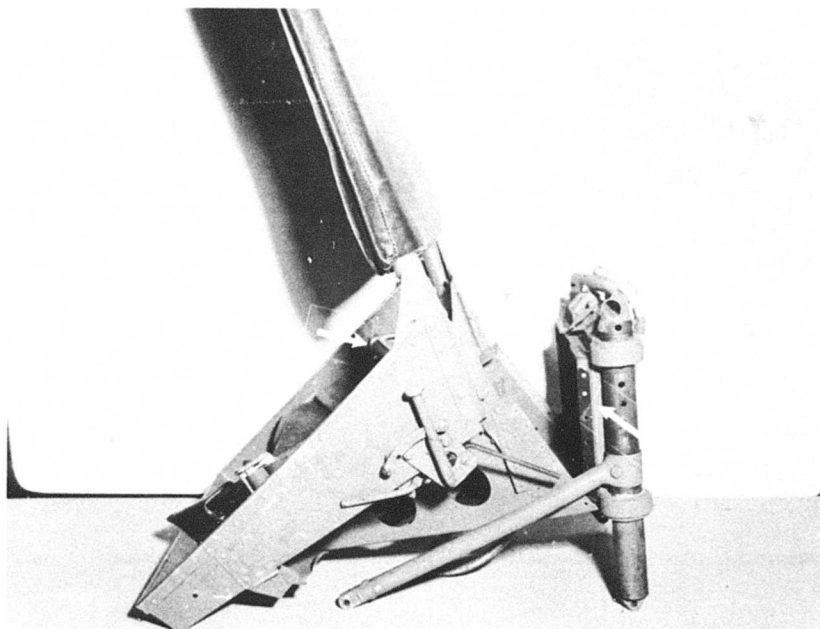
Fig. 32. View of the pilot's seat, showing failure of the seat pan at its left-hand attachment to the rear tubular supporting members (arrow 1). Analysis of the damage to the seat pan indicates that it failed downward and to the left, tearing almost completely free from the rear support assembly. The seat pan, which was free to move in a downward direction, bottomed on the left horizontal support member and/or the cockpit floor structure.

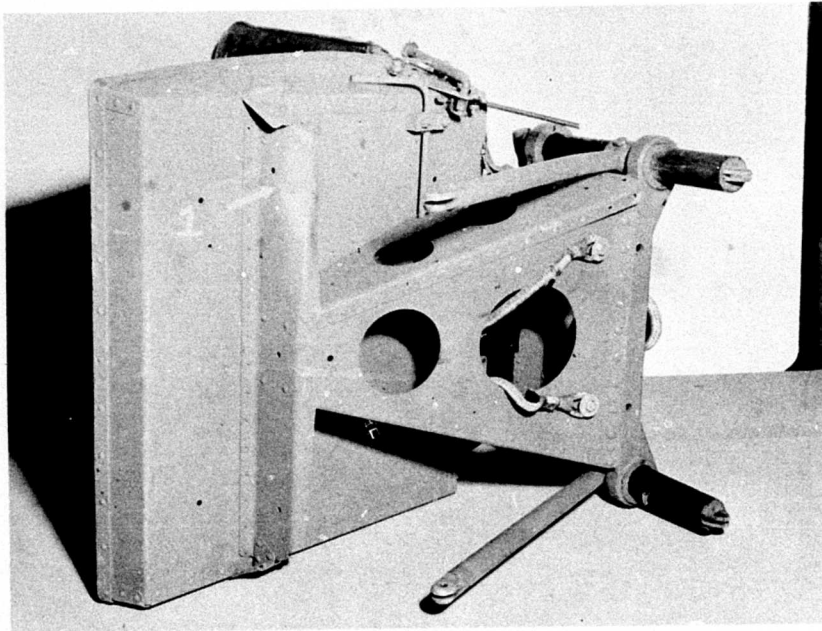
Fig. 33. Close-up view of the underside of the pilot's seat pan, showing bending and distortion of the support bracket (arrow 1) due to bottoming of the seat pan on the horizontal seat-supporting assembly and/or cockpit floor.

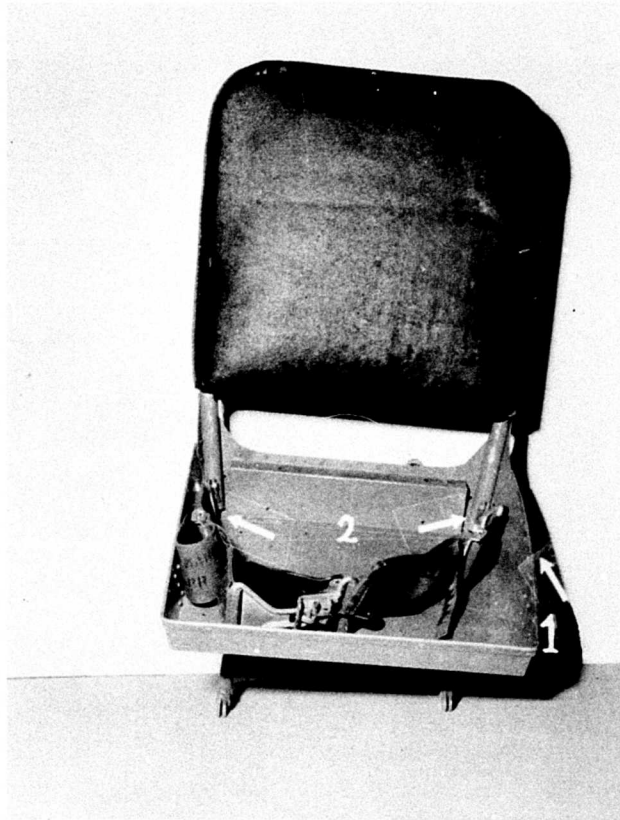
Fig. 34. The outward distortion of the left side of the pilot's seat pan (arrow 1) was due to the pilot's being thrown forward, downward, and to the left during the principal impact.

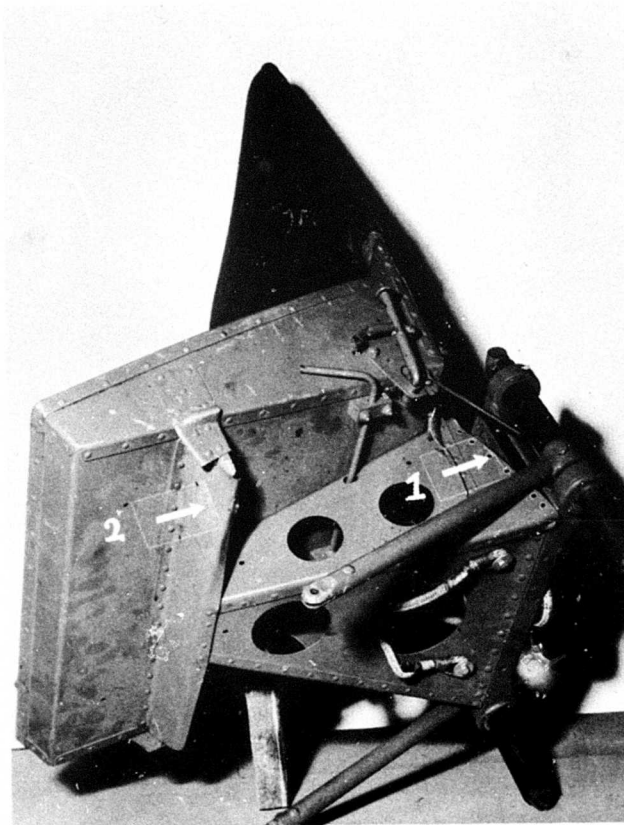
Fig. 35. View of the damage sustained by the pilot's seat, caused by the seat pan's tearing almost completely free from the rear supporting member (arrow 1) and bottoming against the lower horizontal supporting assembly (not shown) and/or cockpit floor. Note bending of the seat pan supporting bracket (arrow 2). Analysis of the damage to the support bracket (arrow 2) indicates that the force with which the seat pan bottomed was relatively low.

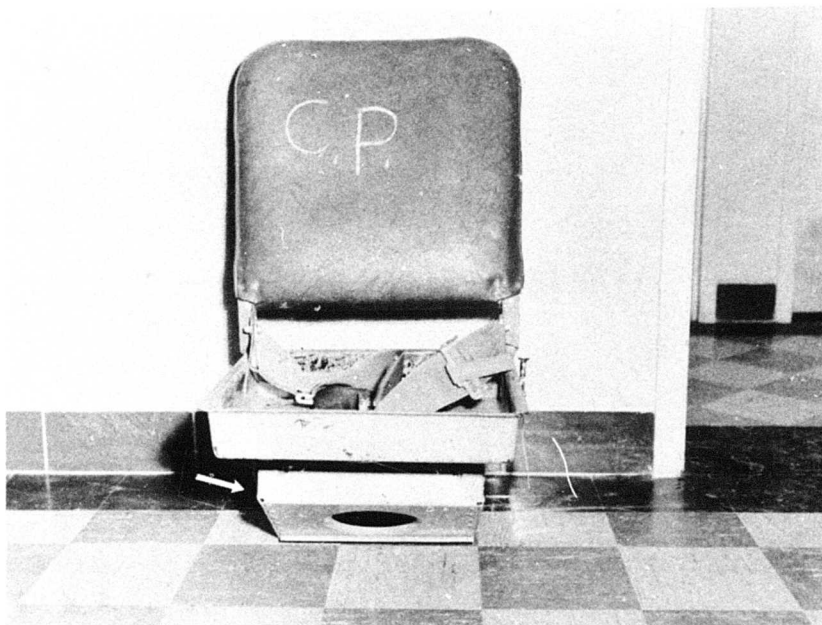
Copilot - The combat scout leader occupying this seat (Figs. 36-37) received minor injuries during his evacuation from the aircraft through the broken windshield. As in the case of the pilot, his restraint system functioned properly, preventing him from striking cockpit structures and components during the crash.

Fig. 36. The copilot's seat was intact and showed no evidence of any damage. Both the occupant's shoulder harness (attached to the bulkhead) and seat belt (attached to a bracket joining the inner rear corners of the seat pan and the vertical seat-back support members) functioned properly during the crash.

The person occupying this seat received only minor injuries, which were apparently sustained during his evacuation from the aircraft through the broken windshield.

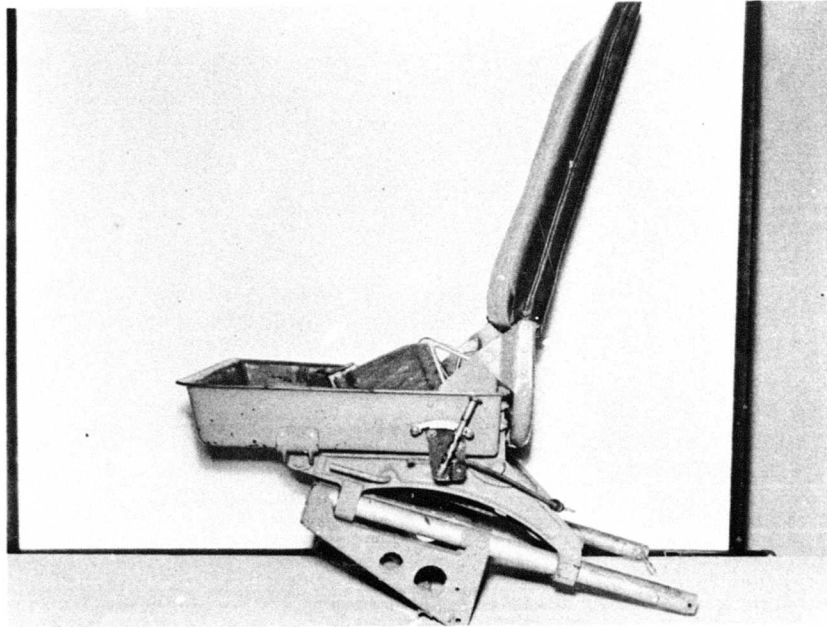
Fig. 37. The copilot's seat, designed to withstand 9g horizontally and a load equal to 6g vertically (upward) when occupied by a person weighing 190 pounds, did not fail, although the calculated crash force apparently exceeded the seat's design limits.

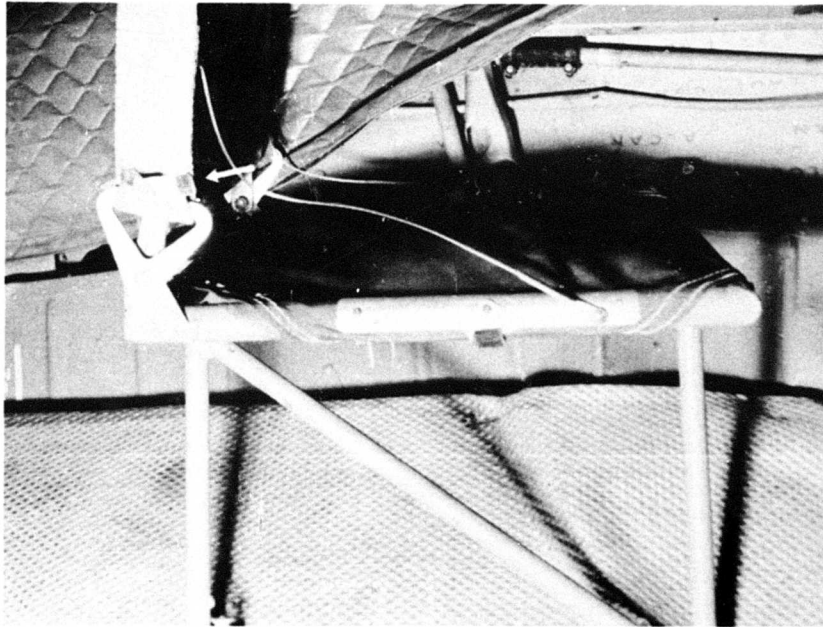
Fig. 38. Seat 1L, which is shown in its normal position in the cabin, remained completely intact during the crash. However, inspection of the safety belt revealed evidence of the beginning of webbing failure near the belt's attachment to the seat (arrow).

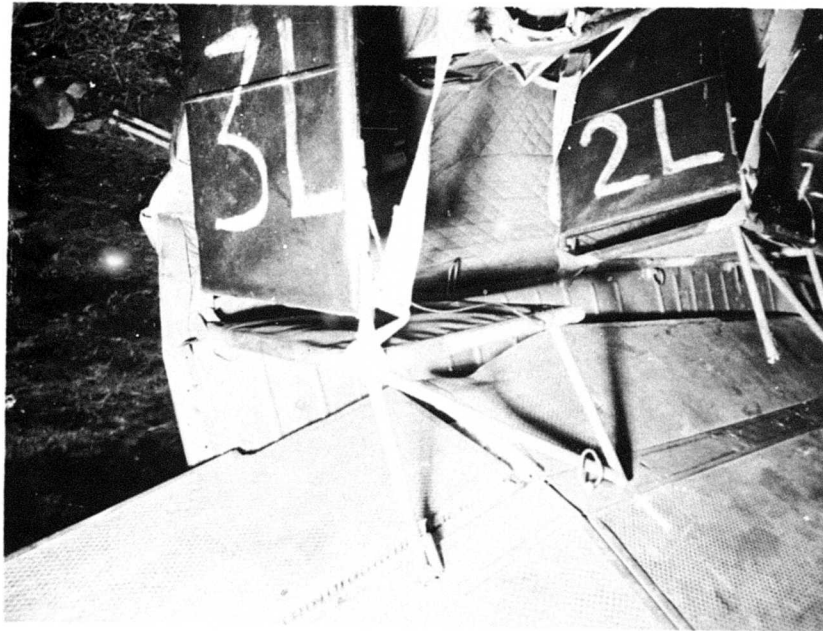
Seat 3L - The occupant of this seat (Figs. 40, 41, 46) received moderate injuries, although seated in the area of the cabin where the ceiling, wall and floor structure was badly buckled and collapsed (Fig. 40). Lacerations above the right eye, bridge of the nose, and upper lip were caused by striking the muzzle of the rifle which he was holding upright between his knees; abrasions of the left temple and front of the left ear were caused by striking adjacent cabin wall structure and/or seat structure in front of him.

Fig. 40. Seat 3L remained intact except for the forward aisle attachment, which was torn free (arrow). The upheaval and separation of the cabin floor between the forward and rear aisle attachments were in the area where the left wheel collapsed upward into the fuselage during the principal impact.

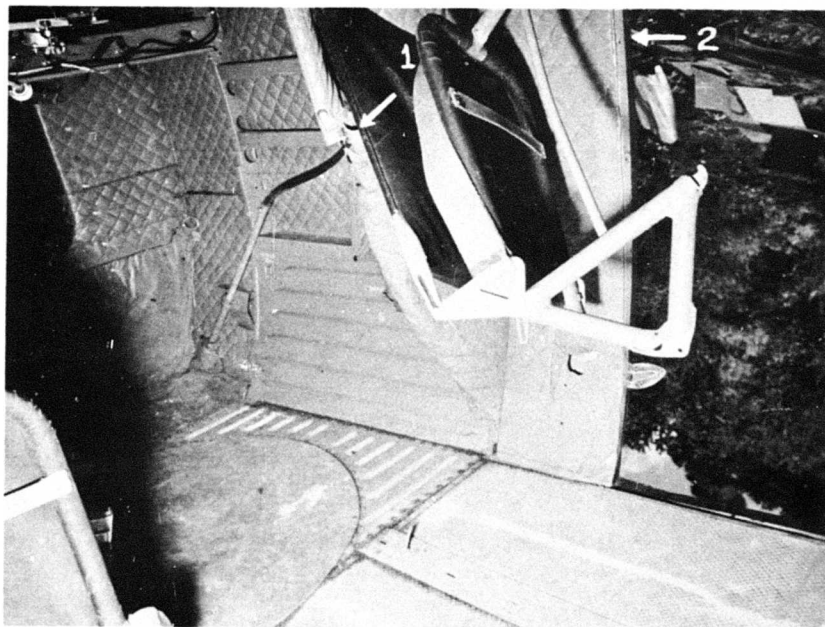
Fig. 42. Seat 4L was torn partially free, remaining attached only to the upper wall fitting. The vertical luggage compartment post, which was utilized as one of the seat attachments, failed completely (arrow 1). Simultaneously, the floor and lower wall attachments tore free and allowed the seat and the belted occupant to move forward, downward, and to the left while pivoting around the intact upper wall fitting. The occupant apparently struck the cabin wall and rear door frame (arrow 2); he sustained moderate injuries.

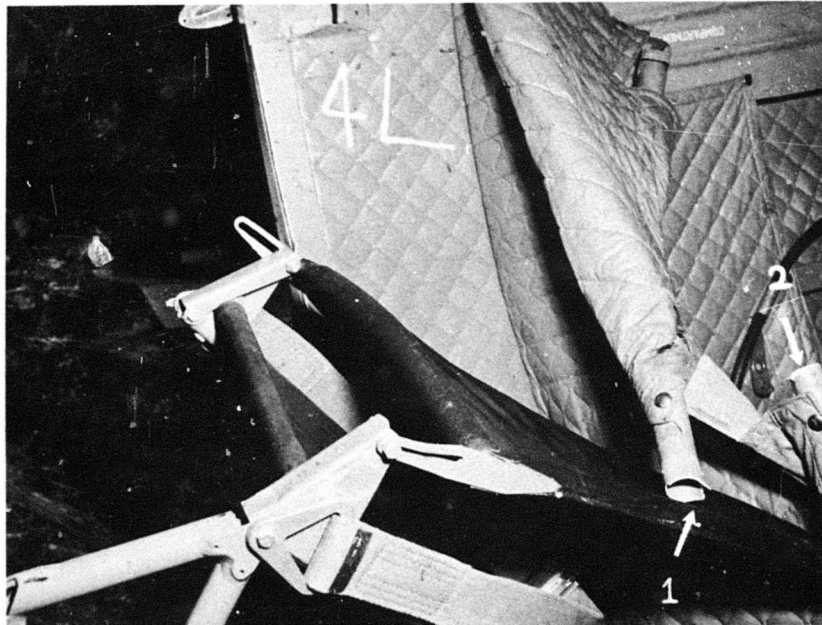
Fig. 43. Failure of the luggage compartment post utilized as one of the seat attachments is shown by arrows 1 and 2.

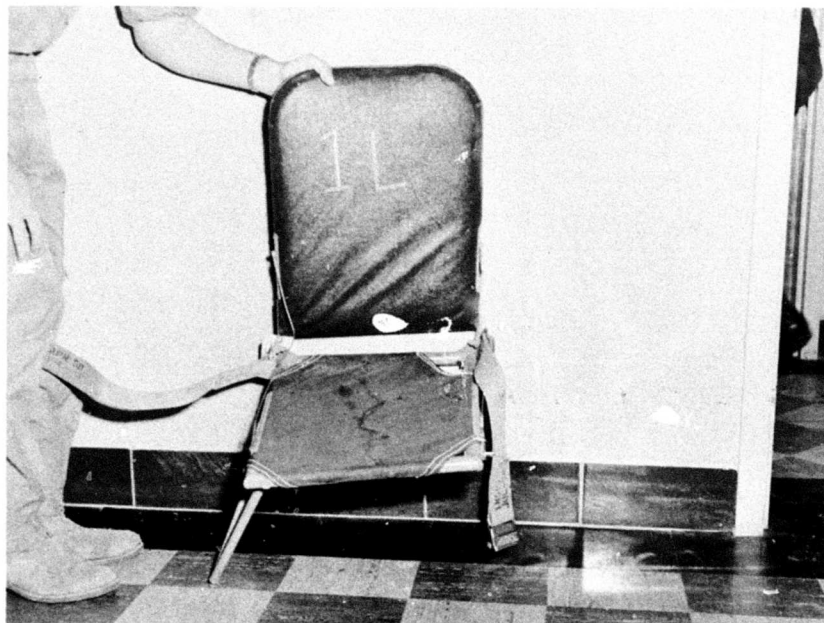
Fig. 44. Seat 1L remained completely intact and in its normal position in the cabin during the crash. However, both aisle floor attachments were distorted, and the safety belt revealed evidence of incipient failure at its anchorages to the seat pan.

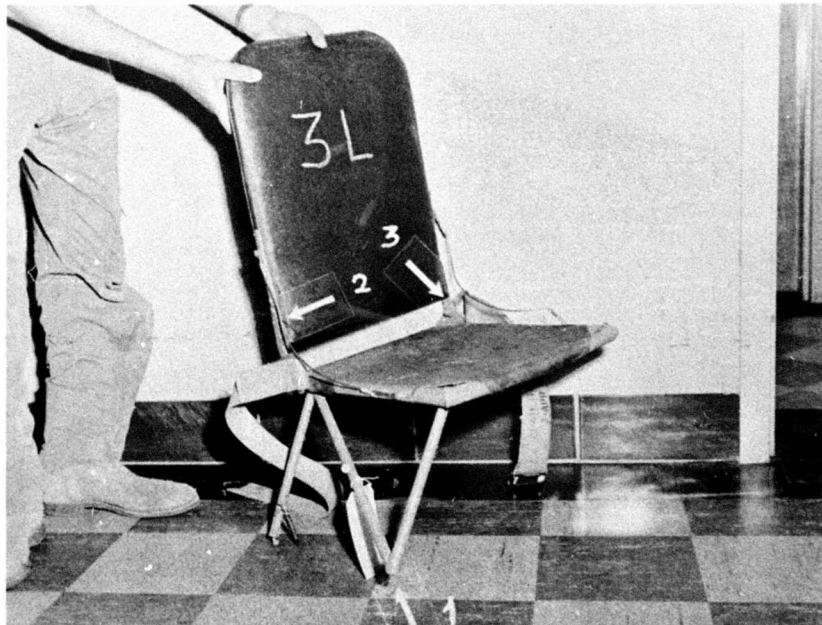
Fig. 46. The forward aisle attachment of seat 3L tore free (arrow 1); the other aisle and both wall attachments were badly distorted. The metal strap (arrows 2 and 3) attaching and hinging the seat back to the seat pan showed evidence of incipient failure. Both safety belt attachments were intact but distorted.

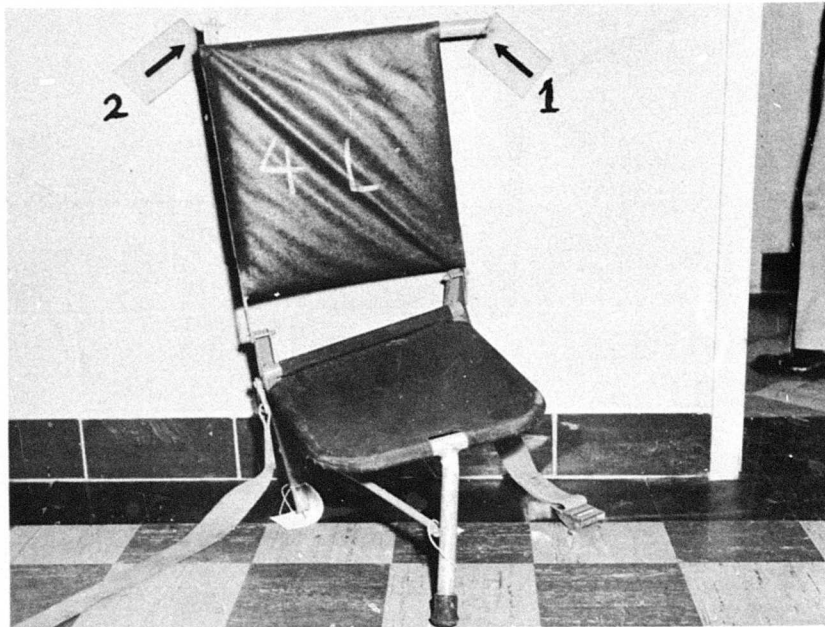
Fig. 47. Seat 4L was torn partially free, remaining attached by only the upper left wall fitting (arrow 1). The seat pan was distorted. Failure of the luggage compartment post allowed the upper right seat attachment (arrow 2) to tear free.

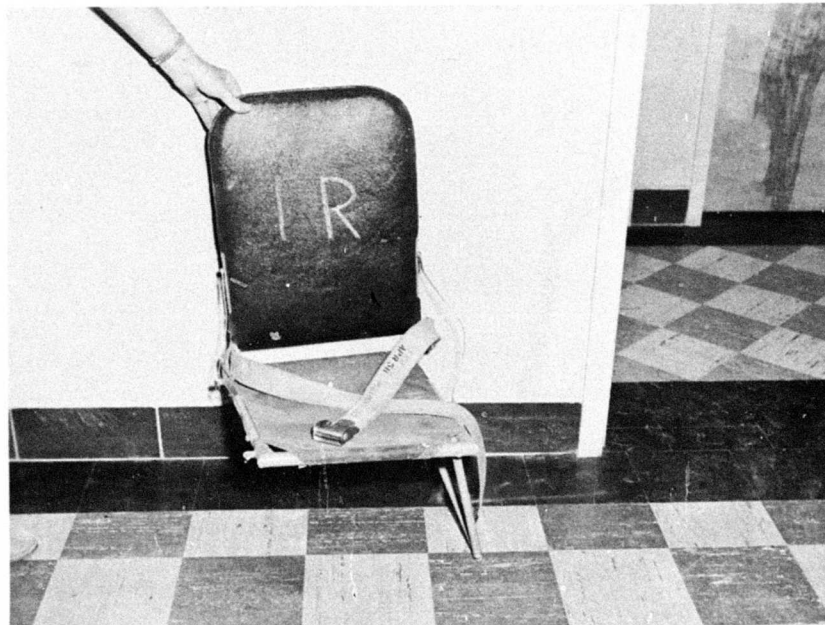
Seat 1R - The occupant of this seat (Fig. 48) received moderate injuries. His injuries consisted of a 4-inch laceration on the top of his head and an abrasion of the left flank. These injuries were caused by striking his head and upper torso against the forward bulkhead, even though he was restrained by his seat belt.

Fig. 48. Seat 1R was the only seat in which the safety belt, seat pan, seat back, and all seat anchorages remained completely intact. The occupant of this seat, who was restrained by his seat belt, received moderate injuries that were apparently caused by his striking his head and upper torso against the bulkhead separating the cockpit and the cabin.

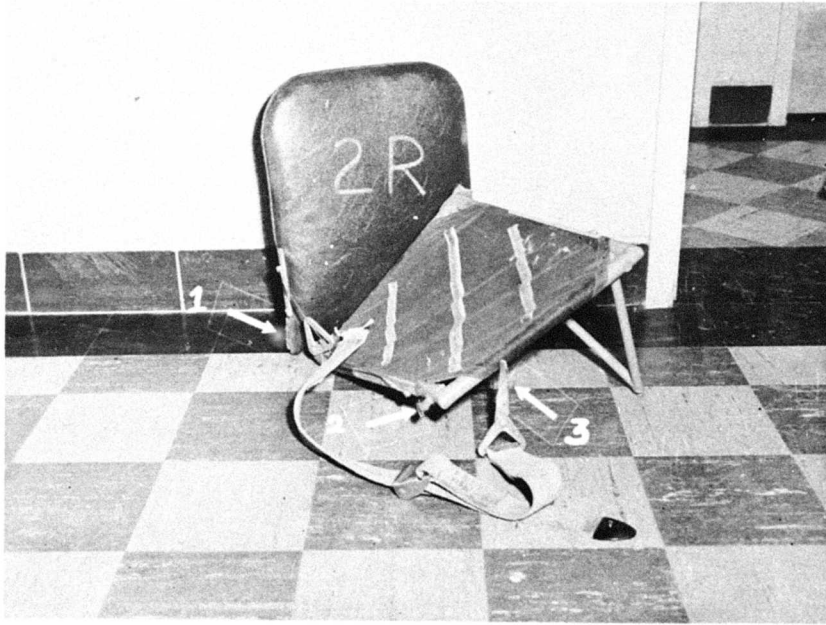
Seat 2R - The occupant of this seat (Fig. 49) was thrown free in the cabin when both his seat and seat belt failed completely. He received moderate injuries which consisted of lacerations on top of his head and above the left eye; abrasions of the shoulder, left hand and right shin. His injuries resulted from (1) being thrown completely free in

Fig. 49. Seat 2R was severely damaged during the crash. The seat back was torn free from the seat pan because both of the metal straps joining and hinging the back to the pan (arrow 1) failed. Both aisle floor anchorages and the rear wall anchorage tore completely free; the forward wall fitting was badly distorted (arrow 2).

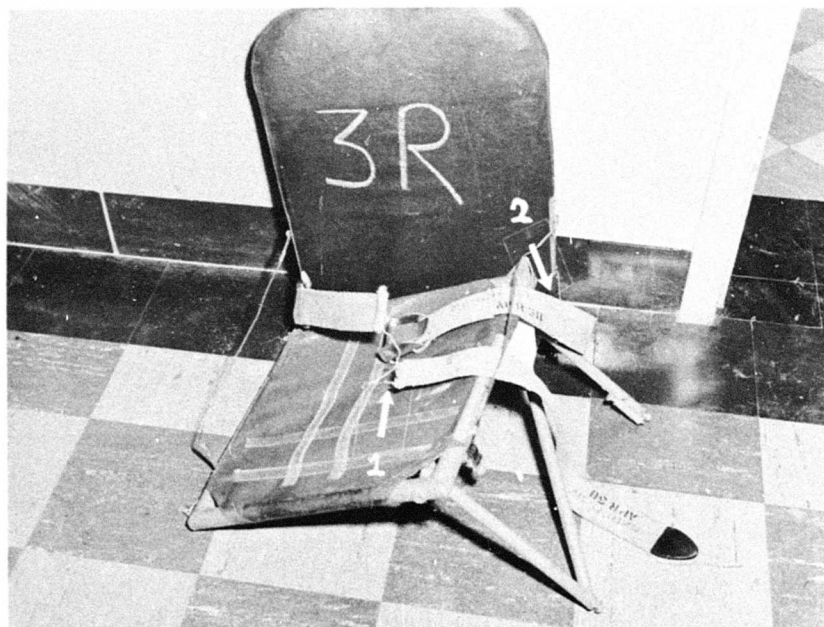
Seat 3R - The occupant of this seat (Fig. 50, 52) received severe injuries and required assistance in evacuating the wreckage. His injuries consisted of a dislocation of the hip and moderate abrasions. The simultaneous failure of his seat anchorages and safety belt allowed him to be hurled through the cabin striking interior structures and components.

Fig. 50. Seat 3R tore completely free because of failure of the wall and aisle floor anchorages. Failure of the metal straps that joined and hinged the seat back to the seat pan allowed the seat back to tear free from the seat pan. The safety belt failed in two places: (a) in the webbing (arrow 1) because of the cutting action of the serrations of the buckle cam, and (b) in the anchorage (arrow 2), which allowed the left-hand portion of the belt to tear free from the seat.

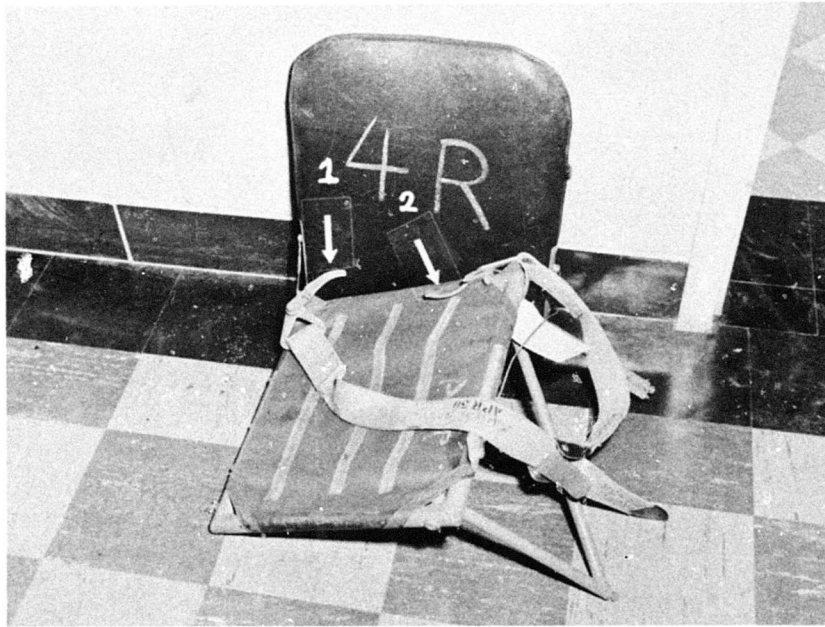
Seat 4R - The occupant of this seat (Figs. 51, 52) sustained minor injuries although the failure of his safety belt resulted in his being thrown forward and to the left across the aircraft cabin. His injuries consisted of abrasions of the left forehead, cheek, and chin and loss of two teeth. It is believed that these injuries were caused by a combination of striking the muzzle of the rifle which he was holding upright between his knees and/or striking interior cabin structures and components.

Fig. 51. Both the wall and the aisle floor anchorages of seat 4R remained intact although badly distorted. The seat back and both safety belt anchorages (arrows 1 and 2) tore completely free because of (a) failure of the metal straps hinging and joining the seat back and seat pan and (b) failures of the brackets attaching the seat belt anchorages to the seat pan.
